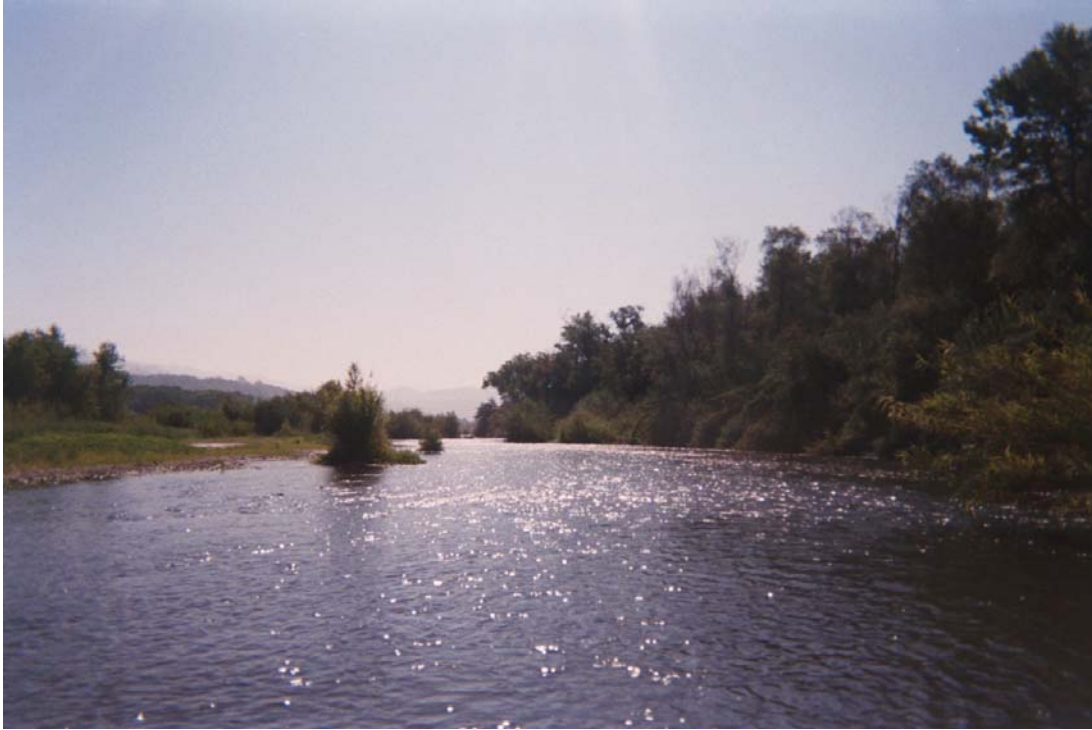
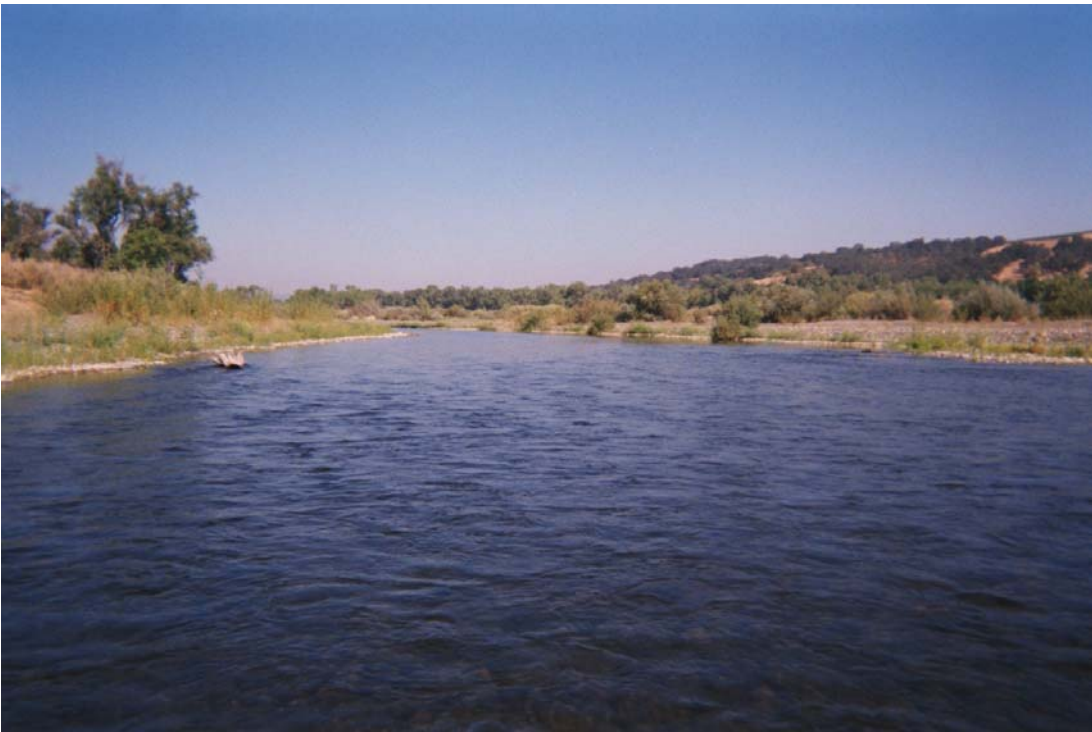
Figure 32: Alexander Valley Reach, Segment A6. This segment contained 98% flatwater, a broad streambed with shallow depths, and sparse riparian cover. No steelhead were observed.

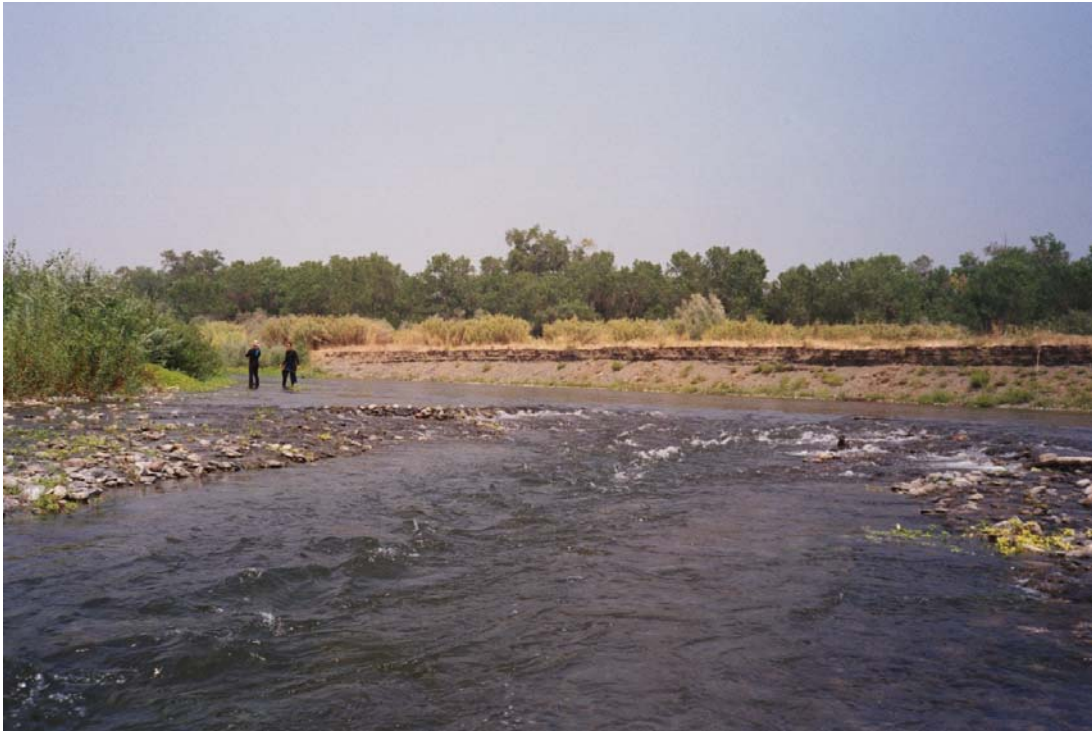
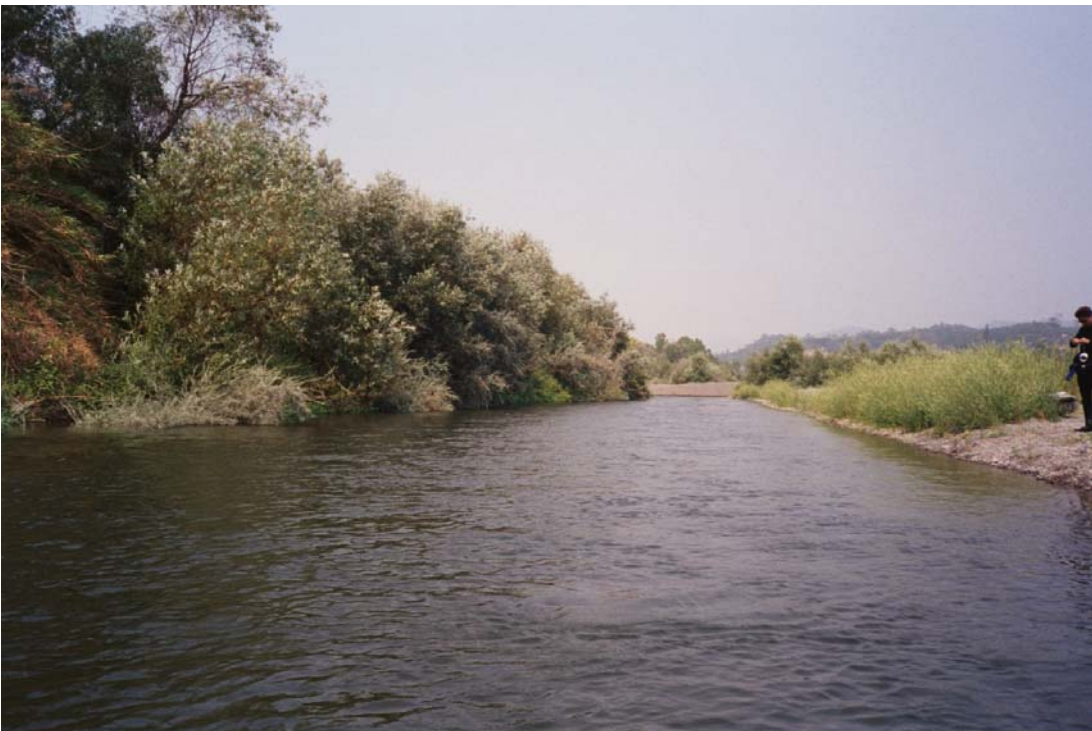
Figure 33: Alexander Valley Reach, Segment A7. This segment contained 40% flatwater and 60% riffle with a gravel substrate. One steelhead was observed in the riffle shown in the top photograph.

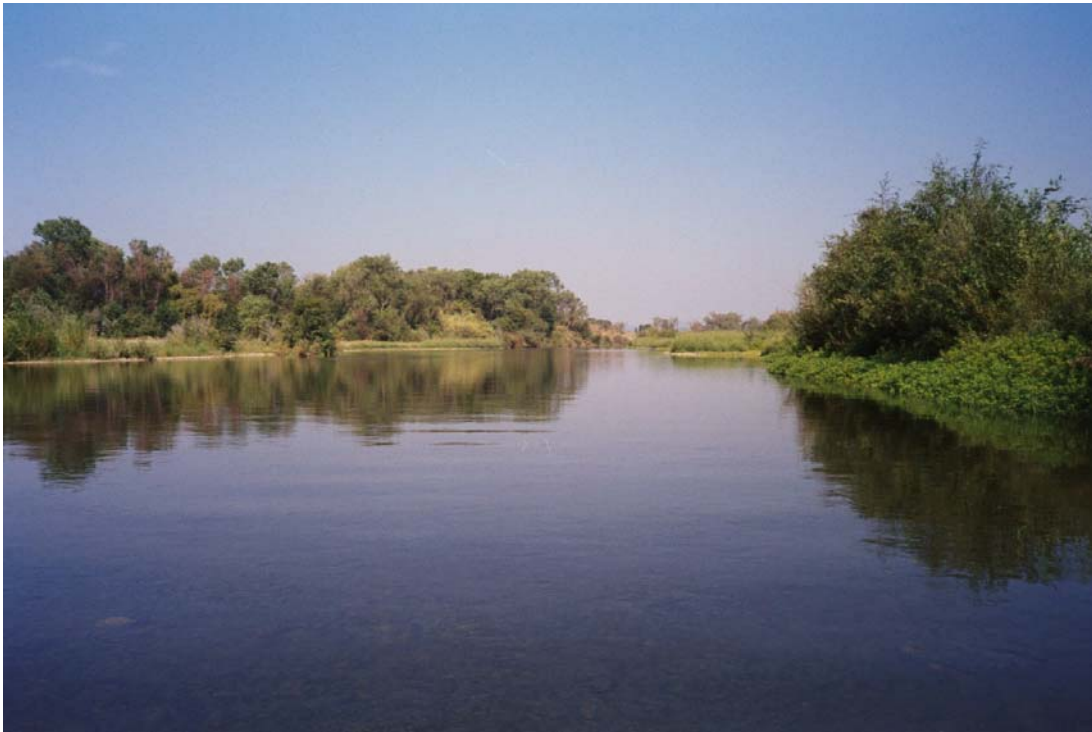
Figure 34: Alexander Valley Reach, Segment A8. This segment contained 83% flatwater, 15% riffle, and 2% deep pool. Flatwater is shown in both photographs. No steelhead were observed.

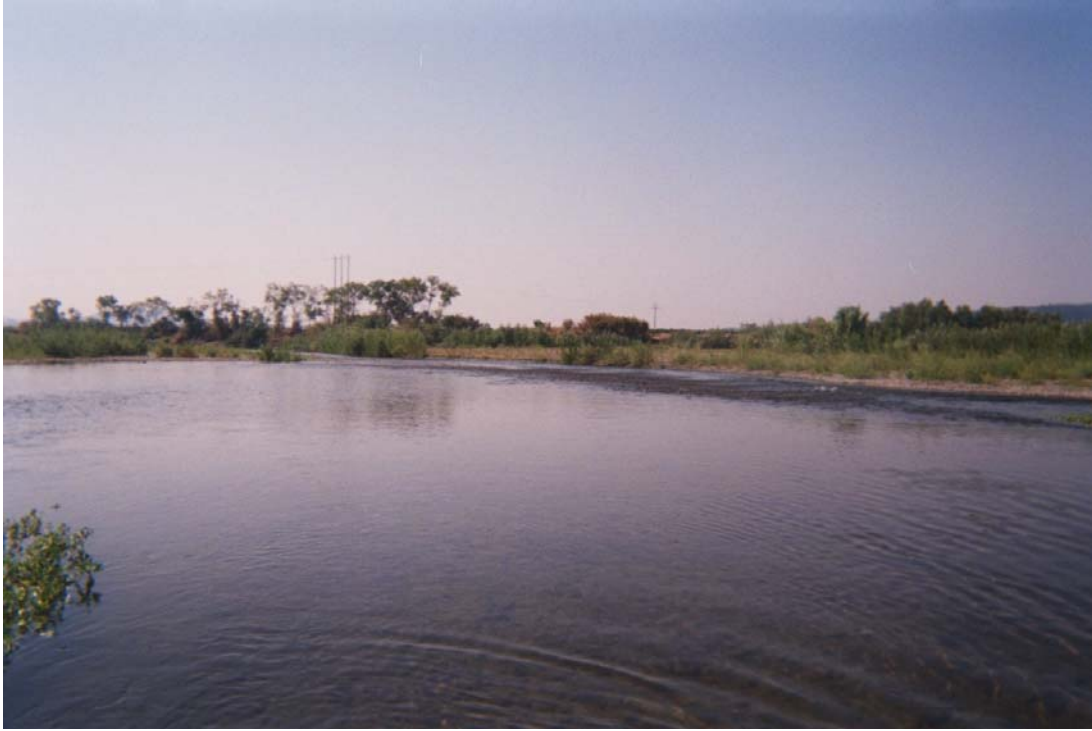
Figure 35: Alexander Valley Reach, Segment A9. This segment contained flatwater, had a broad streambed with shallow depths, and sparse riparian cover. No steelhead were observed.

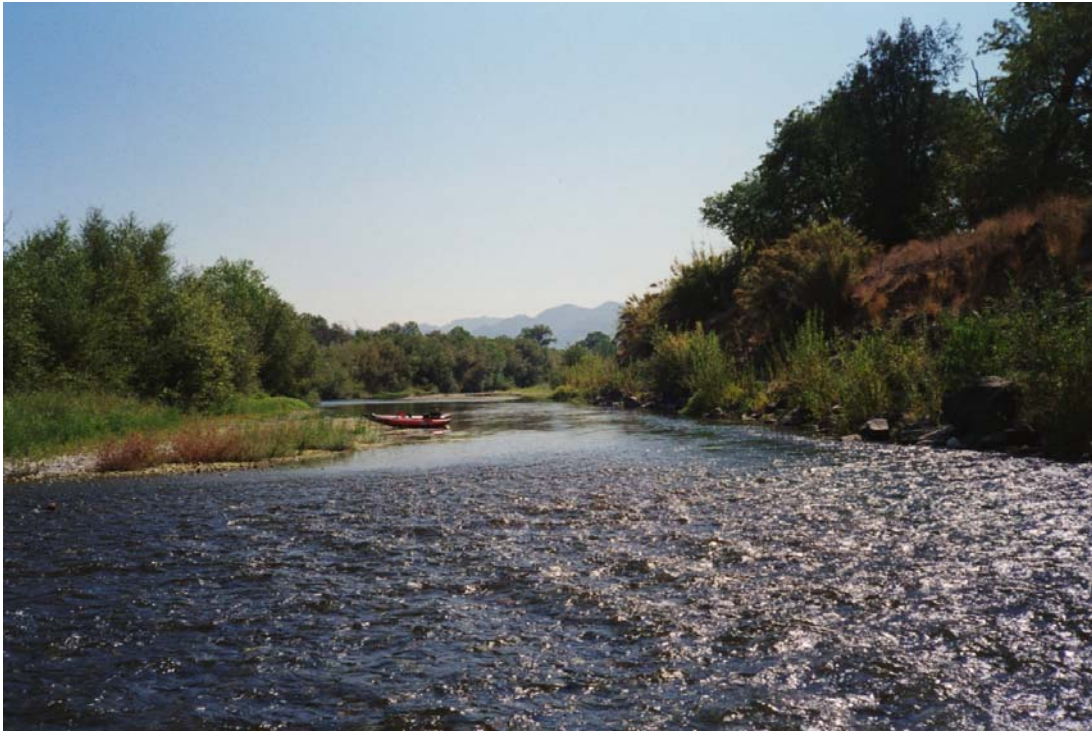
Figure 36: Alexander Valley Reach, Segment A10. This segment was dominated by flatwater (95%) with occasional shallow riffles and deep pools. No steelhead were observed.
